DEPARTMENT OF TRANSPORTATION**DIVISION OF ENGINEERING SERVICES**

Quality Assurance and Source Inspection

Contract #: 04-0120F4Cty: SF/ALA Rte: 80 PM: 13.2/13.9File #: 69.28**WELDING INSPECTION REPORT****Resident Engineer:**Pursell, Gary**Address:** 333 Burma Road**City:** Oakland, CA 94607**Report No:** WIR-001000**Date Inspected:** 23-Nov-2007**Project Name:** SAS Superstructure**OSM Arrival Time:** 630**Prime Contractor:** American Bridge/Fluor Enterprises, a JV**OSM Departure Time:** 1530**Contractor:** Zhenhua Port Machinery Company, Ltd (ZPMC), Changxing Island **Location:** Shanghai, China**CWI Name:** Lu Jian Ping**CWI Present:** Yes No**Inspected CWI report:** Yes No N/A**Rod Oven in Use:** Yes No N/A**Electrode to specification:** Yes No N/A**Weld Procedures Followed:** Yes No N/A**Qualified Welders:** Yes No N/A**Verified Joint Fit-up:** Yes No N/A**Approved Drawings:** Yes No N/A**Approved WPS:** Yes No N/A**Delayed / Cancelled:** Yes No N/A**Bridge No:** 34-0006**Component:** Tower Mock-up and OBG**Summary of Items Observed:**

CALTRANS Quality Assurance (QA) Inspector, Alfredo Acuna was present for the fabrication scheduled for this project at the ZPMC facility in Sh

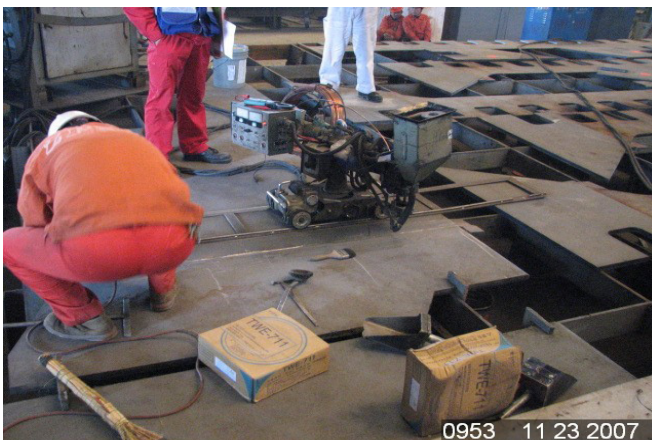
Item Description	WBS	Dwg No.	Status
1 OBG Mock-up Floor Beam			
The QA inspector observed welder Yin Guo Qin performing submerged arc welding operations at the joint FB-002-E-019-026.

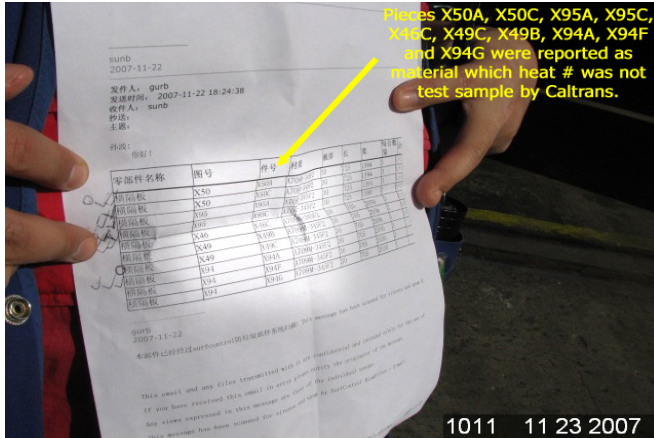
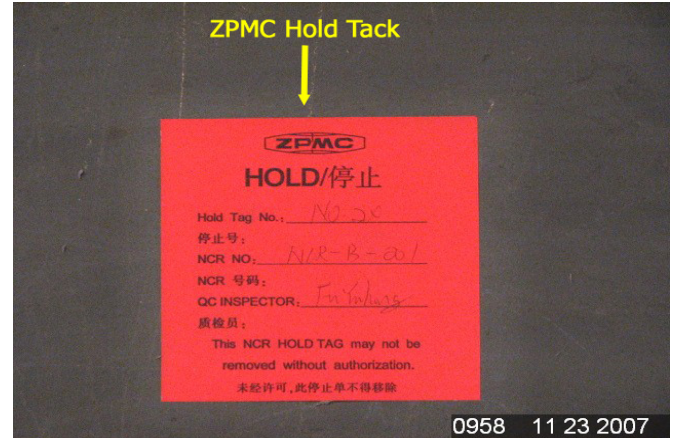
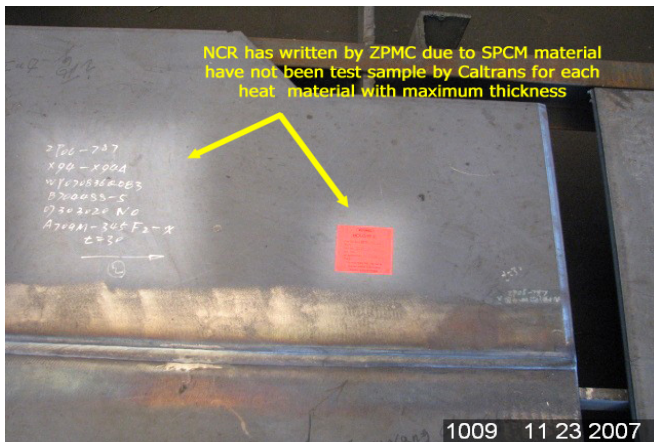
2 ZPMC internal NCR Check Testing

The QA inspector had conversation with ZPMC representative Mr. Fu Yu Hong, the QA inspector asked Mr. Fu Yu Hong the reason for the hold tags that he was attaching on the steel. Mr. Fu Yu Hong relayed that the ZPMC was issuing a internal non conformance report (NCR) because ZPMC started production activities without Caltrans check testing on the 30 mm plates designated as Seismic Performance Critical Members (SPCM) as shown on the photographs below.

The QA inspector had a conversation with ABF representative Mr. Steve Lawton. The QA inspector relayed to Mr. Steve Lawton that Caltrans would write a non conformance report (NCR) due to ZPMC cold bent (mechanical bending with a press) material designated as Seismic Performance Critical Members subassemblies MA-25 and MA-26, 3 webs and 6 flanges.

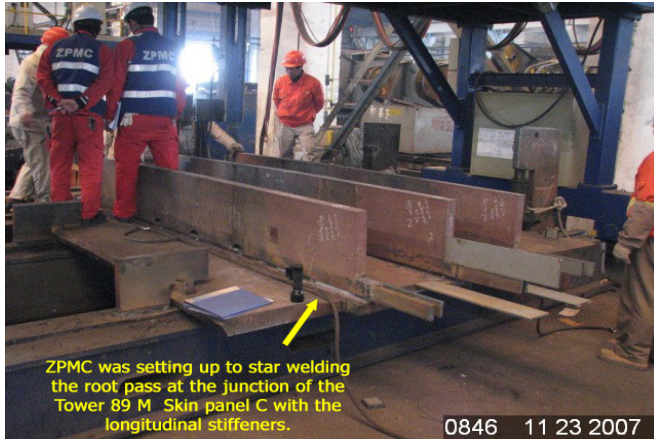
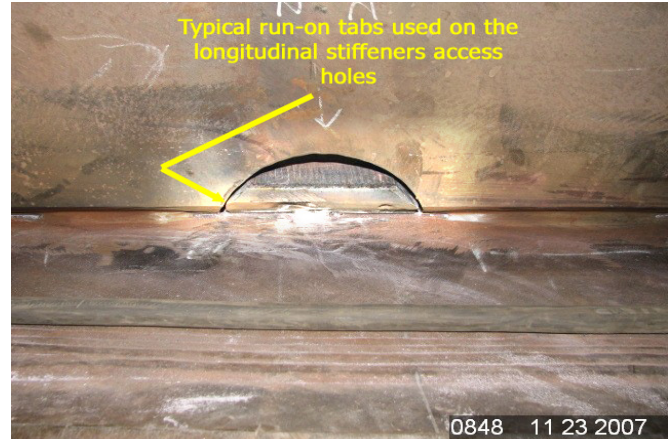
3 Tower Mock-up 89 M Skin C

The QA inspector observed ZPMC to start welding with the flux cored welding (FCAW) Gantry machine at the junction of the Skin C to the longitudinal stiffeners to the mp507-1. The photograph below shows ZPMC gantry machine and the skin C and the run on tabs by the access holes.
